**FIELD SURVEY AND SITE ASSESSMENT OF  
MOSQUITOES AT KINTYRE CAMP  
IN JUNE AND DECEMBER 2011**

Report 2012/160

**Client: Cameco**

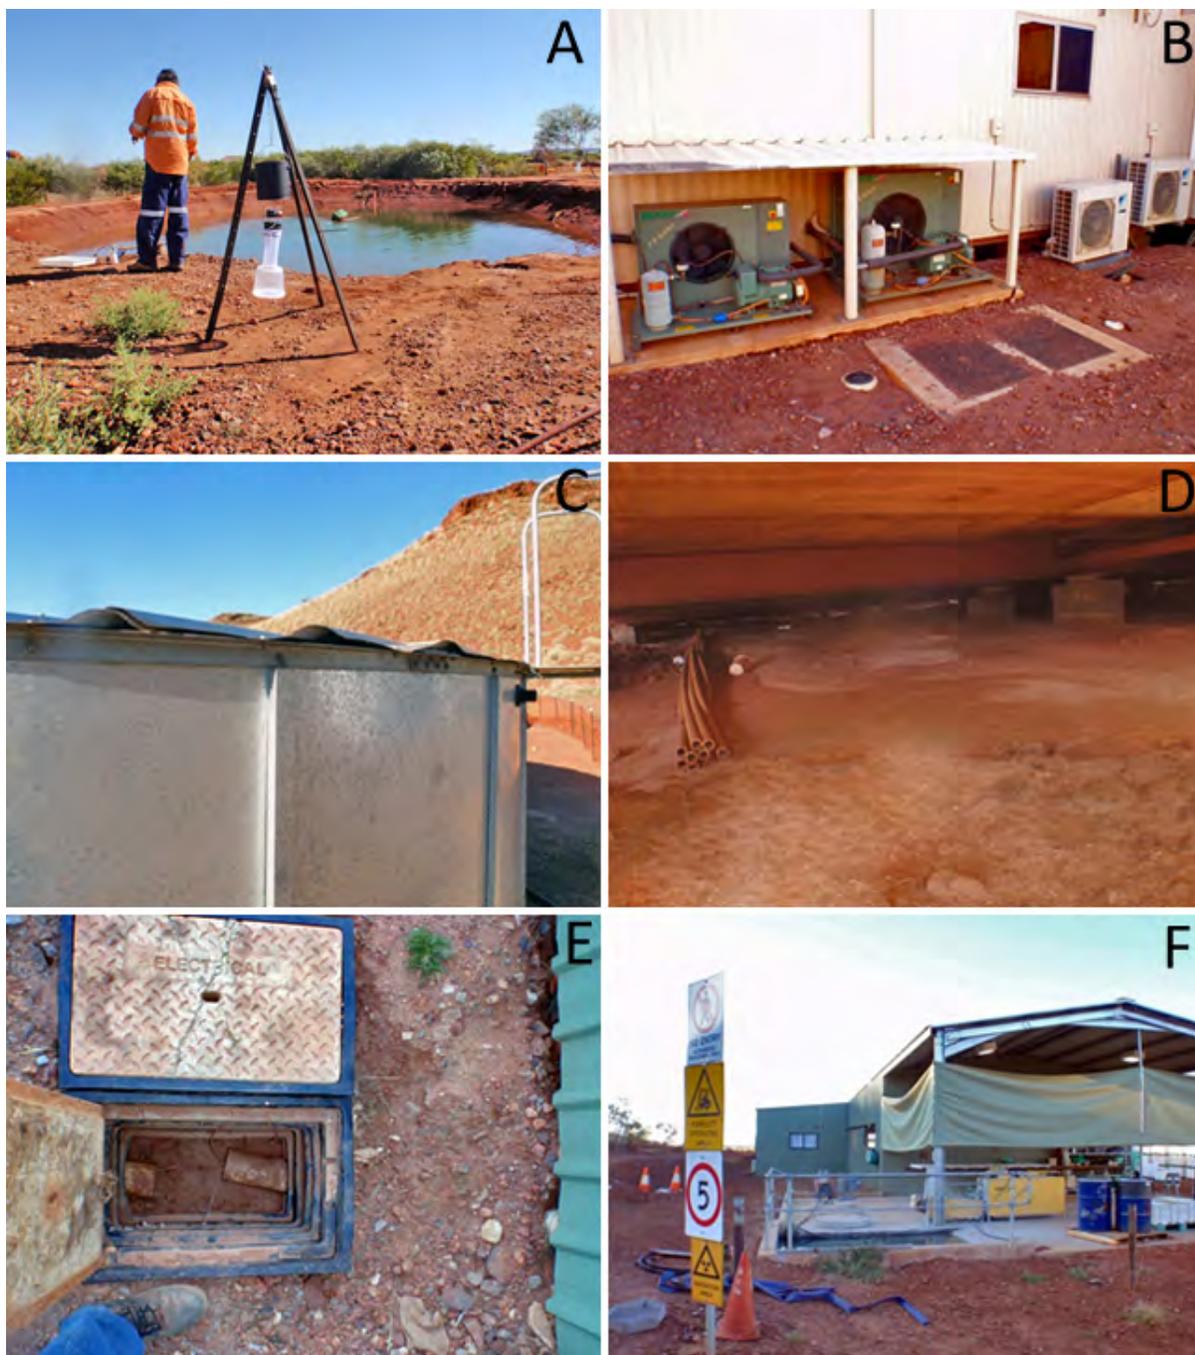
**Figure 1. Potential mosquito breeding areas.**

A. CO<sub>2</sub> light trap.

B. Back of the kitchen showing an unscreened vent and surface water access beneath the building.

C. Water storage tank showing unscreened roof.

D. Evidence of surface water drainage and pooling under building.

E. Electrical maintenance access pit showing evidence of inundation.

F. Core Shed wash down facility with unavoidable pooling water.

The traps were set away from ambient light an hour before dusk by suspending them from a tree branch or from a purpose built tripod (Figure 1a) so that the entrance to the capture net was set at about 60 cm above ground level. The traps were set up-wind of likely mosquito sources to facilitate CO<sub>2</sub> dispersal over the potential source, and to attract mosquitoes towards the trap. Traps were emptied an hour after dawn. The plastic containers holding trapped insects were placed directly into an 'Eskey' containing dry ice for a period of ten minutes, after which the mosquitoes were transferred to a labelled vial

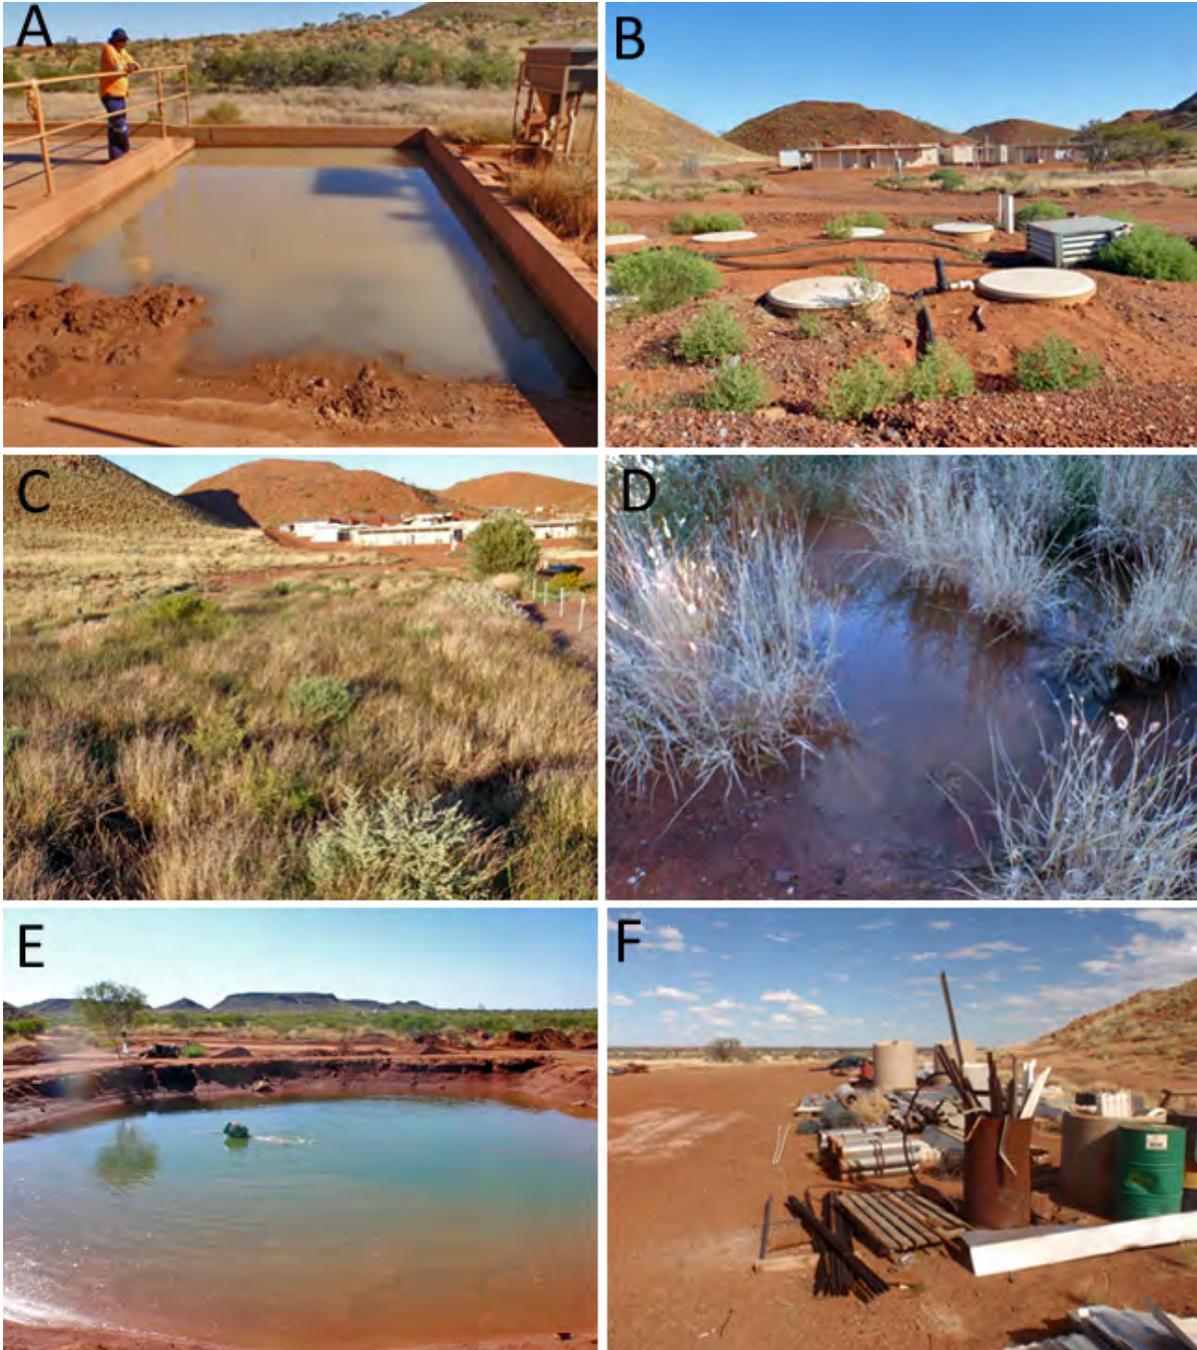
**Figure 2. Potential mosquito breeding areas.**

**A.** Vehicle wash down facility with unavoidable pooling water.

**B.** Sunken sewerage settlement tanks at WWTP.

**C.** Heavily vegetated evaporation pond at WWTP.

**D.** Pooling water in evaporation pond at WWTP.

**E.** Turkey Nest dam.

**F.** Equipment laydown area.

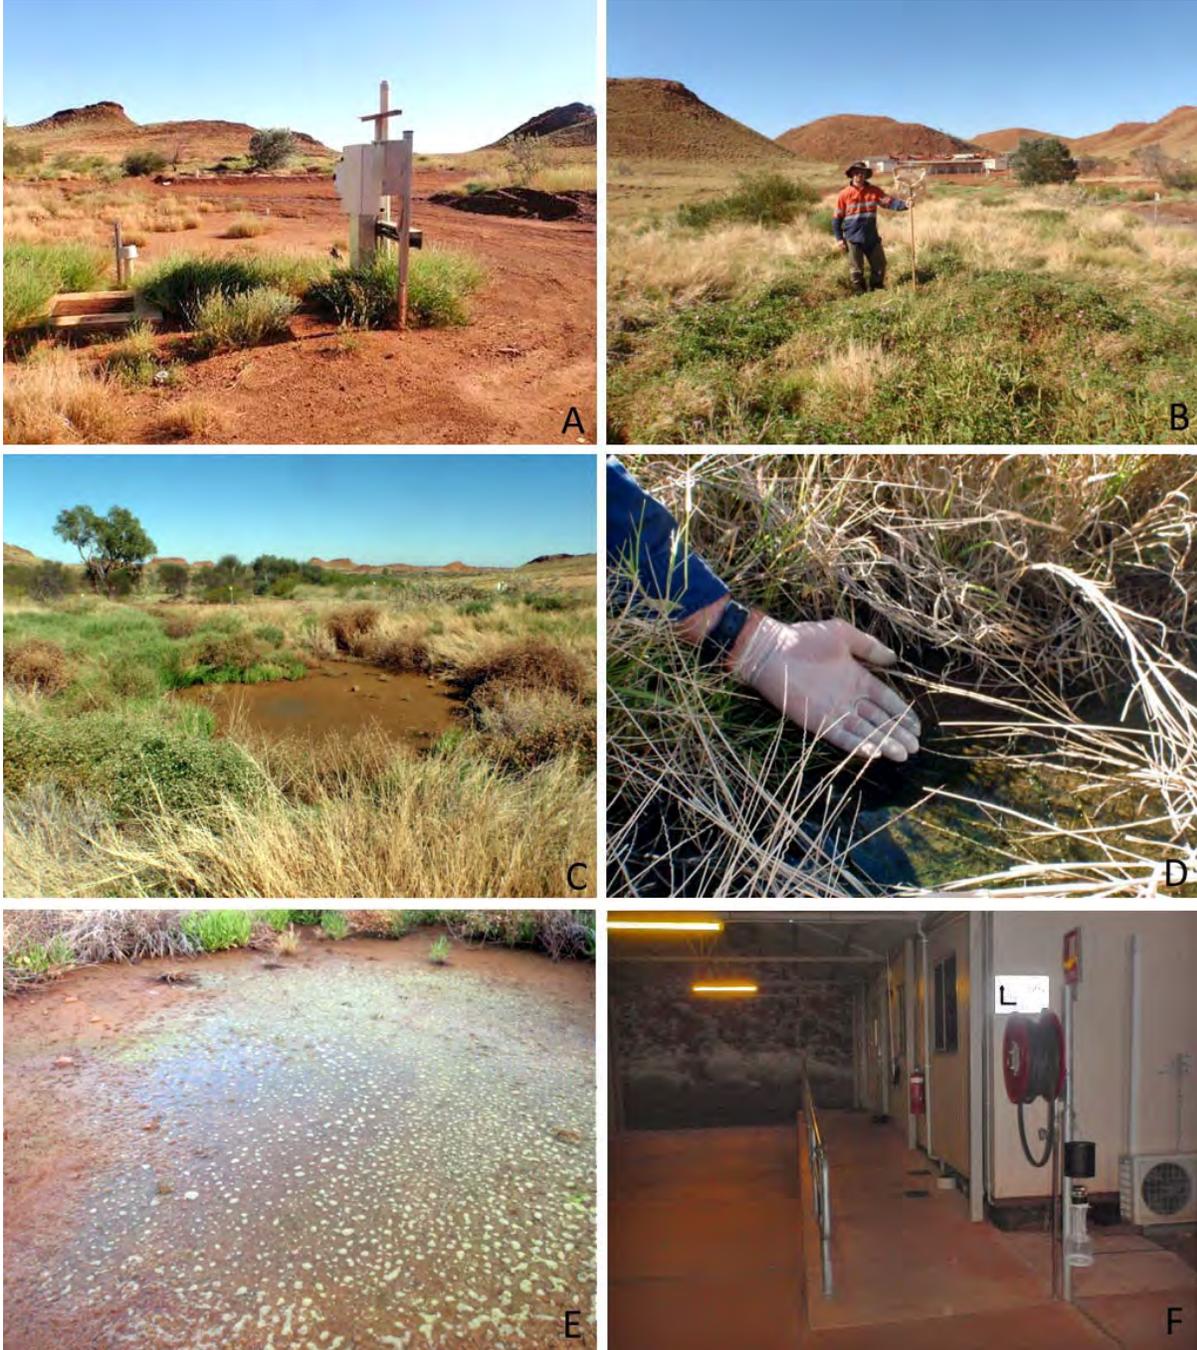
**Figure 3. Potential mosquito breeding areas.**

**A.** WWTP showing primary ponds (fore ground) and evaporation pan (back ground)

**B.** Dense vegetation over most of the WWTP evaporation pan. In the fore ground is *Ipomoea muelleri* concealing patches of surface water.

**C.** WWTP big pool with low water level and Buffel Grass in the foreground and *Pluchea rubelliflora* around the edges of the pool.

**D.** WWTP linear trench normally concealed by grass showing water to a depth of 4 cm that hosts significant mosquito breeding.

**E.** Pool A with deeper water.

**F.** A CO<sub>2</sub> light trap adjacent to the meeting area –a reported mosquito biting location. Efficiency of the trap is reduced by ambient lighting that could not be eliminated.

- The WWTP contains shallow pooled water surrounded by dense weed growth. Waste water treatment and disposal facilities are broadly recognised as potential breeding sites for mosquitoes and this is the case at Kintyre Camp. For this reason, consideration could be given to modifying the design of the WWTP to either eliminate pooling, or to construct deeper, steep and smooth sided pools with no aquatic vegetation or dense vegetation close to the pool perimeters. The pools should be easily accessible for maintenance, monitoring and the application of larvicides when required.

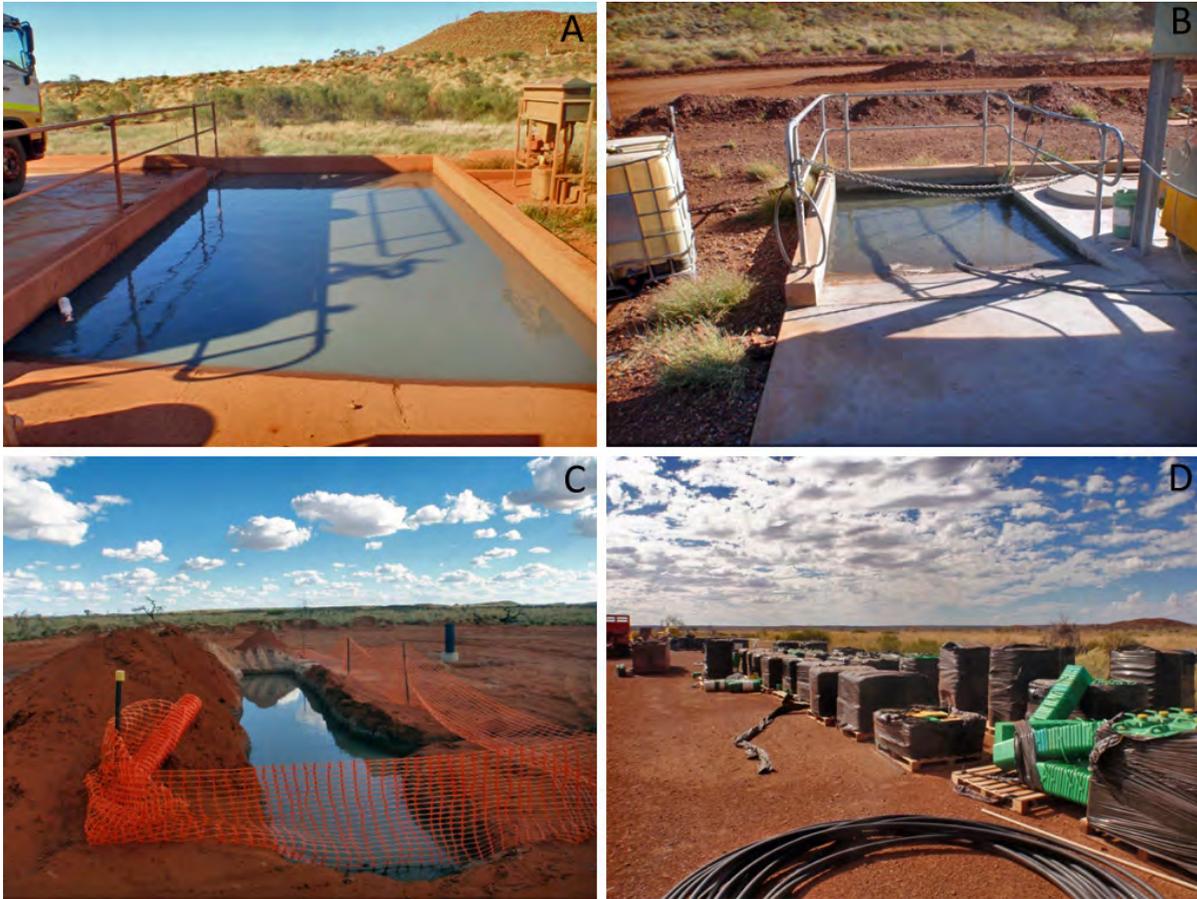
**Figure 4. Potential mosquito breeding areas.**

- A.** Vehicle wash down facility. Standing water occurs here to a depth of about 30 cm at the distal end and overlies a heavy sediment load.
- B.** Core Shed fines settlement tank showing a lid covering one of 3 circular overflow tanks at the right.
- C.** Drill water retained in a shallow ditch
- D.** Piles of equipment in laydown area capable of holding water for extended periods during rain seasons.

- The vehicle wash down contains surface water in the concrete washing facility and the drainage sump (Figure 4a). Both sites contain hydrocarbon contamination typical of such facilities and no mosquito larvae were observed visually or recovered with the 250 um sweep net.
- The fines wash down at the core shed comprise a settlement apron that holds water to about 25cm depth and drains into a series of three small tanks each holding about 500 litres beneath aluminium lids (Figures 1f, 4b). The water in these tanks is very clear. Tadpoles and some water beetles but no mosquito larvae were observed visually. High levels of chironomid larvae were observed in the sediments of the fines apron water obtained with a 250 um sweep net. No mosquito larvae were recorded.

- Sumps and wash down facilities unavoidably provide standing water with the potential for mosquito breeding. While no larvae were collected, these facilities require monitoring to determine when chemical or biological control is required.
